## Case Study

# FACILITY UPGRADE Ontario, Canada

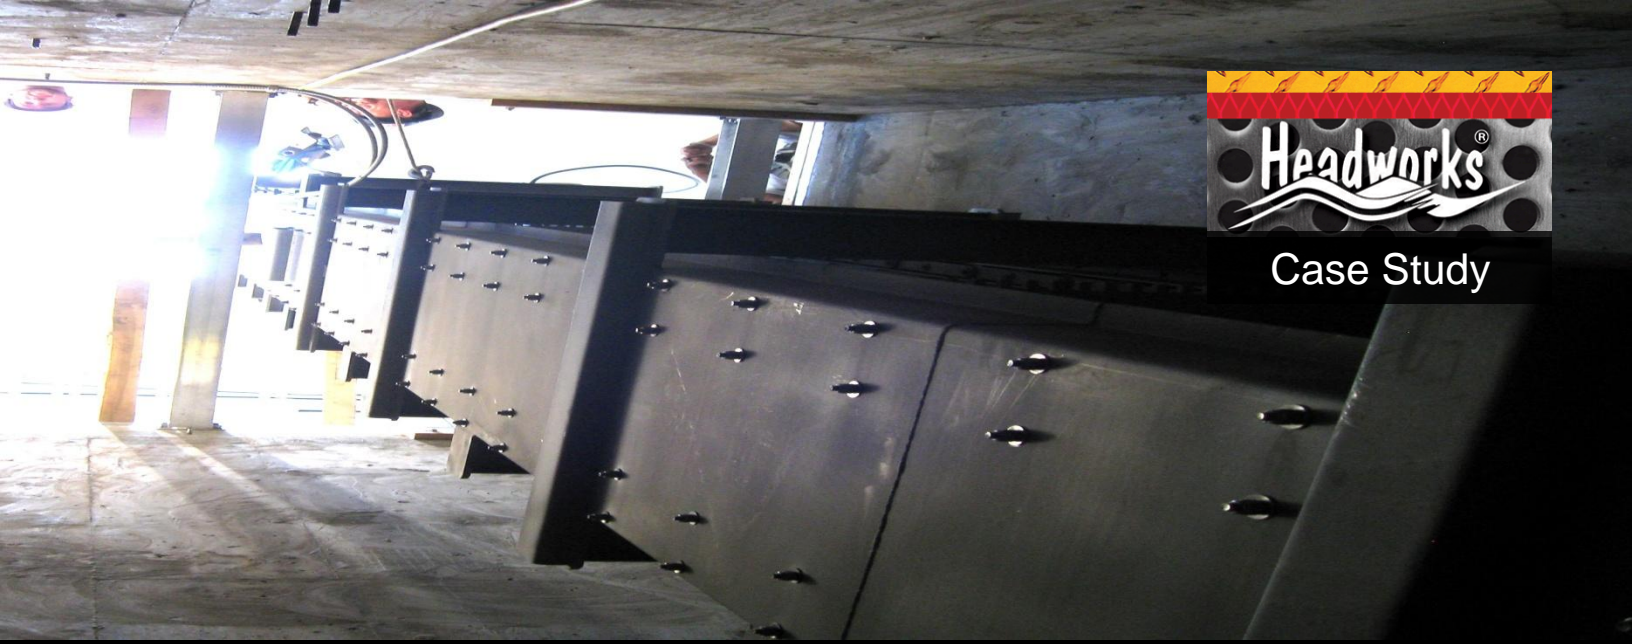
In 2008, H2O Ontario was selected as the contractor for the project. The upgrades included the complete refurbishment of the preliminary treatment section of the plant. The design entailed the supply and installation of a new mechanical screen with bar spacing of 0.5 inch (13mm) that had to meet difficult and unique challenges at this application.

The second factor was the limited space available in, around and above the new screen room. These constrictions made it necessary for the one-piece 31-foot (9.50m) long screen to be designed to rest at a 90-degree angle and installed through a specially designed hatch in the room's rooftop.
