### Mahr® Bar Screen Solves Odor & Debris Issues at Water Reclamation Facility

# Camrosa WRF - Camarillo, CA

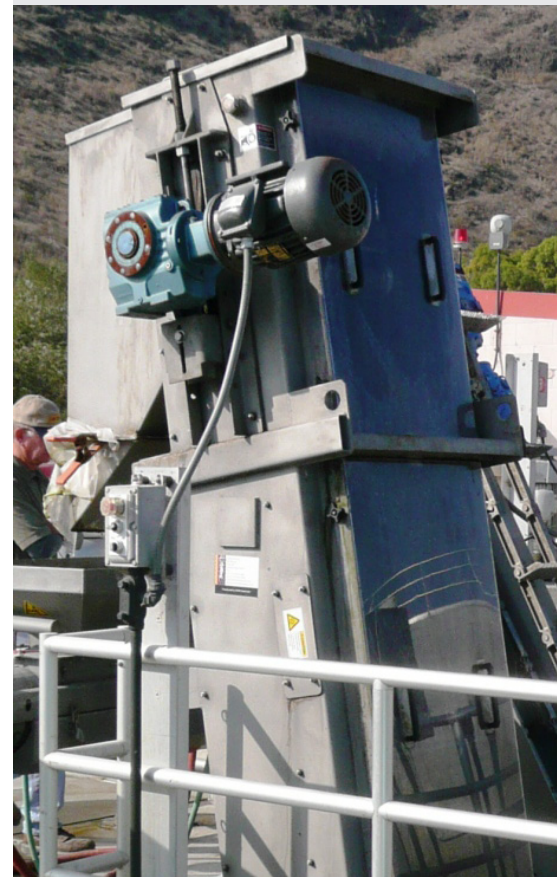
*Debris collected on the old screen's chains and scraper mechanisms that frequently required cleaning.*

Also, due to a lack of lower bearing and cross members in the screenfield, the screen would build up with debris that would blind off portions of the screen. The debris against the bars would result in the bending of the rake fingers exacerbating the problem even more. The removal of this debris required someone to go down into the channel, a confined space entry. Since the screen was not enclosed, debris was spread across the plant's grounds, requiring additional cleaning. The mess and smell of sewage attracted swarms of flies making the working conditions unpleasant. The facility personnel realized the screen needed to be replaced.
